MEMORANDUM

RE: Command Roofing, Building 16, 2045 Dryden Road

Conestoga-Rovers & Associates has prepared this memorandum to document the current conditions at the Command Roofing Building (Building 16), located at 2045 Dryden Road and to provide recommendations regarding vapor intrusion mitigation measures at this building. On June 22, 2011, representatives of CH2M Hill, Ohio EPA, the Respondents, and CRA completed a building survey of Parcel 5174, Building 16, located at 2045 Dryden Road, occupied by Command Roofing. The building survey was completed in order to gather information necessary to develop a vapor intrusion (VI)-specific conceptual site model (CSM). Attachment A presents photographs of Command Roofing Building 16. A Building Physical Survey Questionnaire form with CRA, Ohio EPA, and/or CH2M Hill observations is provided in Attachment B. The CSM includes building information such as building use, design, floor slab condition, and VOC and methane concentrations measured at nearby investigative locations. Figure 1 presents the CSM for Command Roofing Building 16.

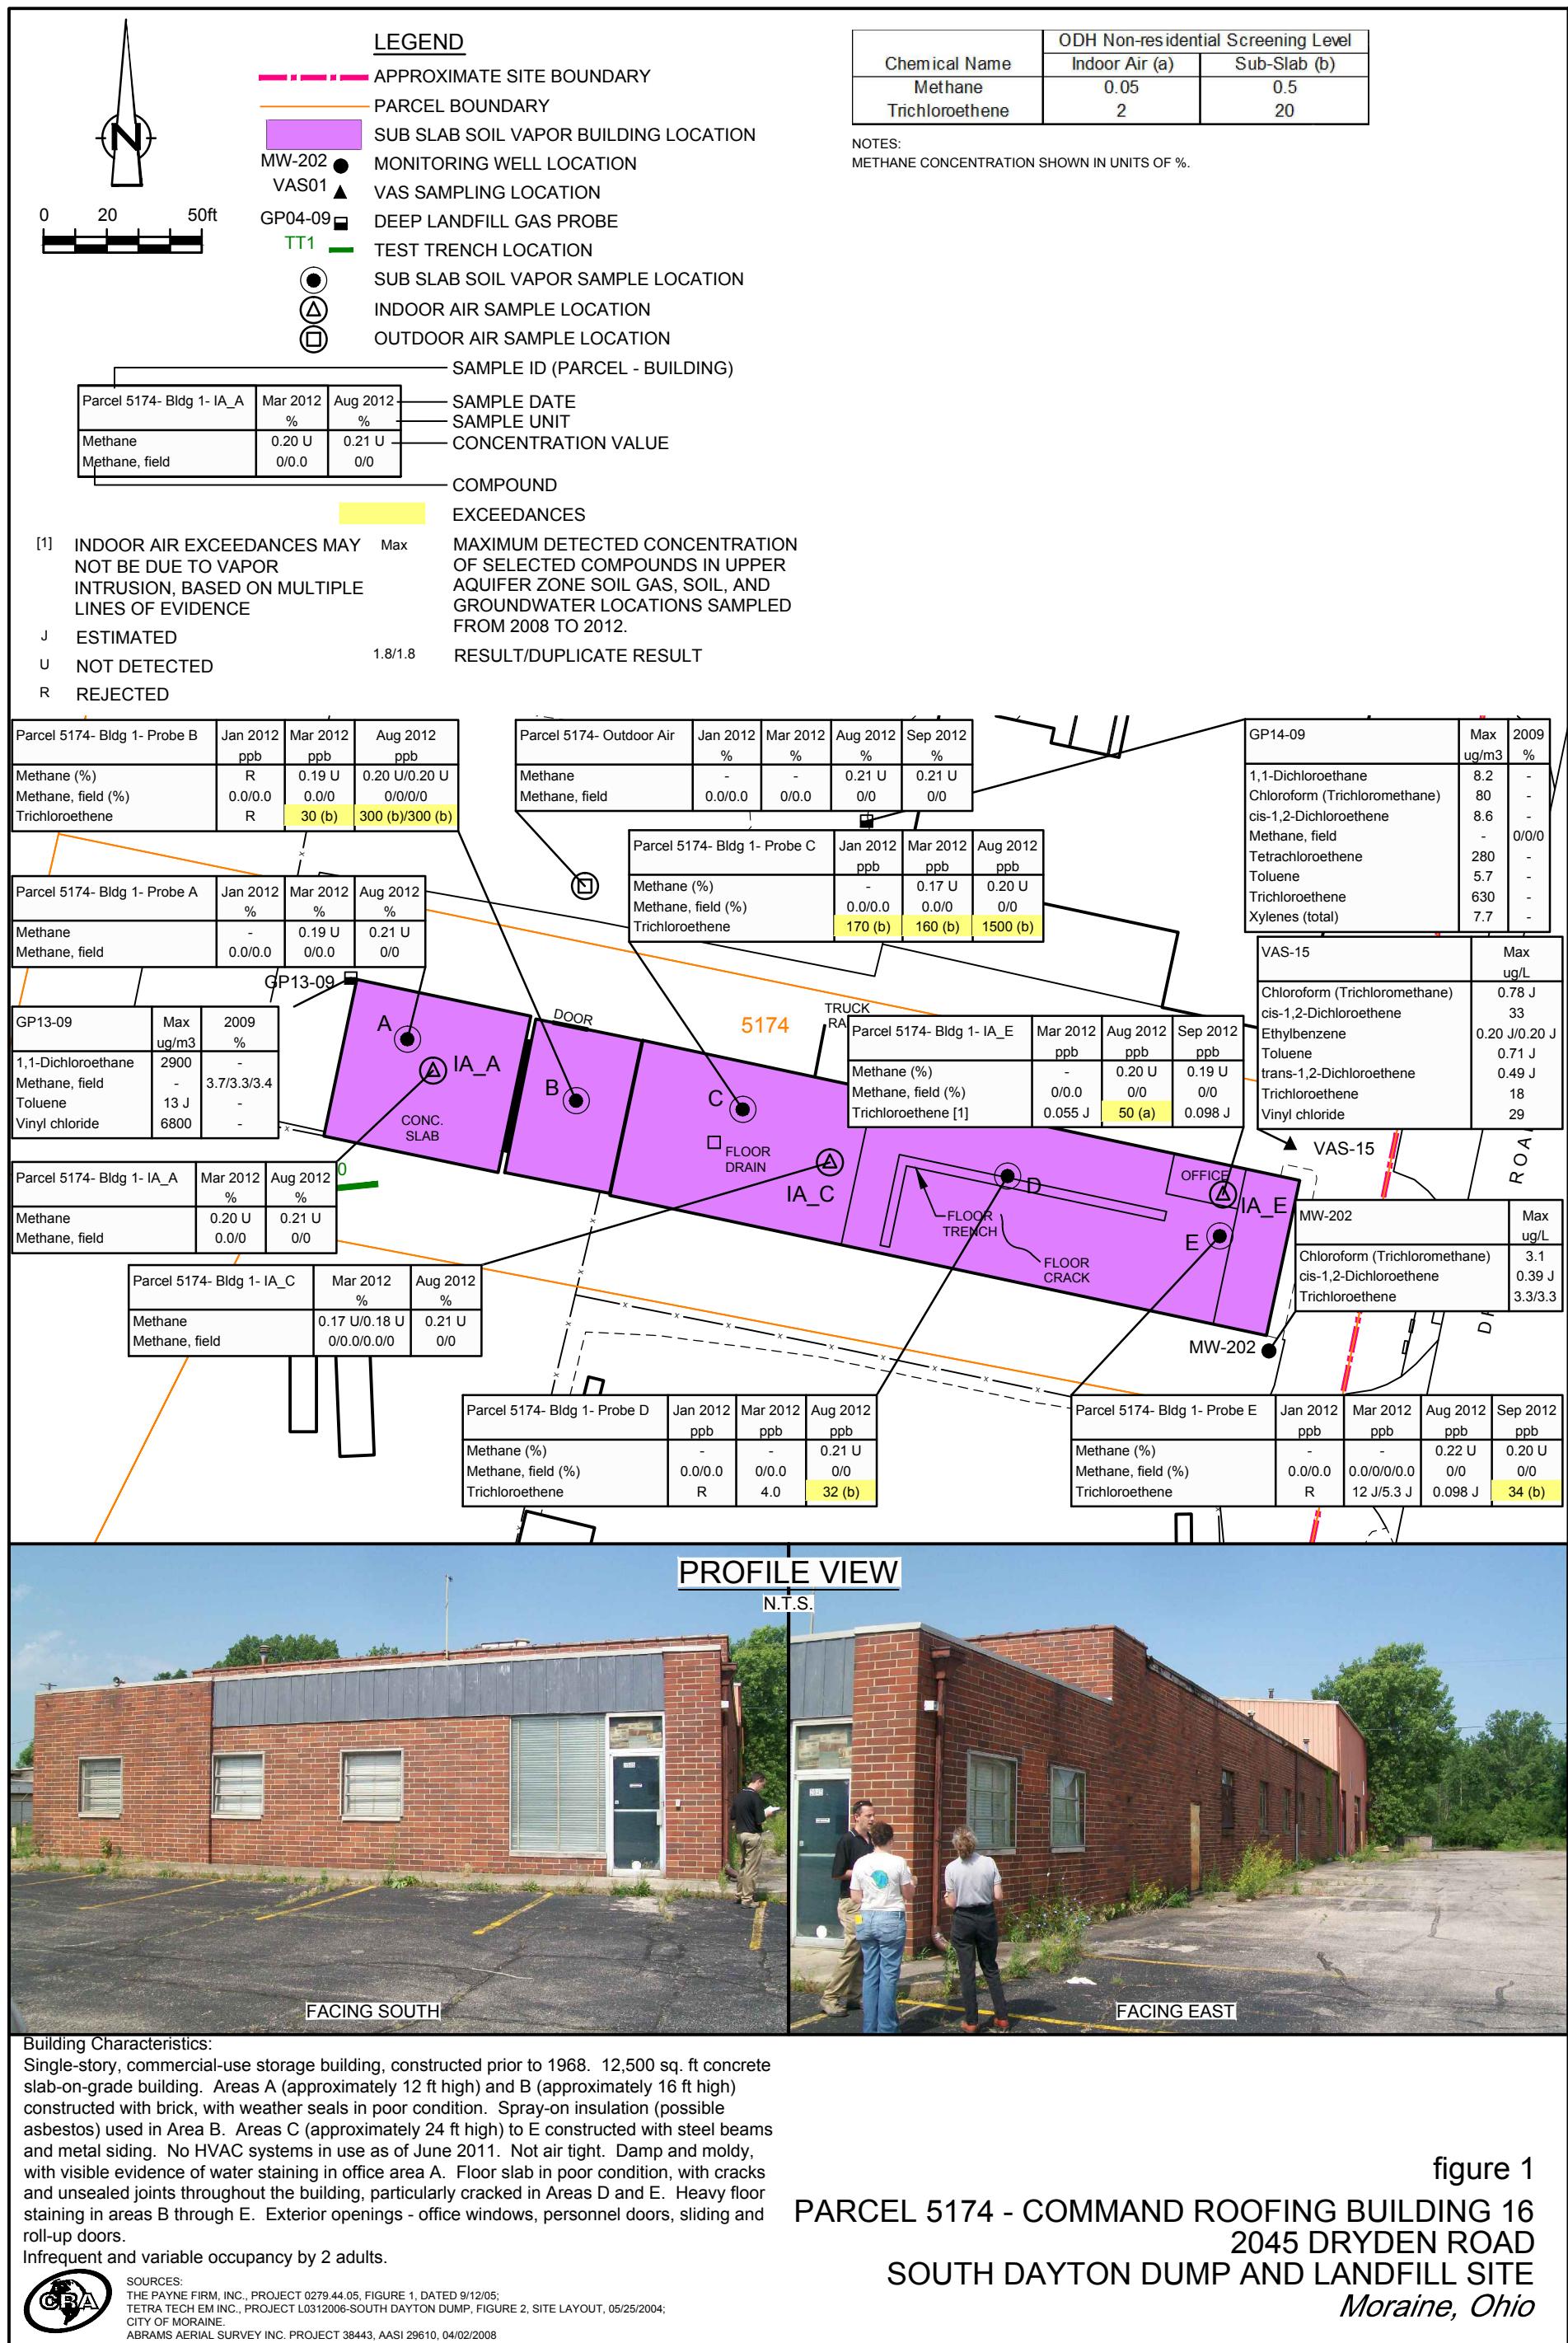
which was greater than the ODH IA screening level criteria of 2 ppb, and the action level of 20 ppb. During the August 2012 VI sample event, Command Roofing employees were storing material in the building; this material may have contributed to IA and SS concentrations. Photograph 12 in Attachment A shows the material stored during the August 2012 VI sample event. CRA completed confirmatory IA sampling in September 2012. The September 2012 confirmatory IA sample contained TCE at a concentration of 0.098 J ppb, which is less than the ODH screening level. The confirmatory SS sample contained TCE at a concentration of 34 ppb, which was greater than the ODH SS screening level, but less than the ODH action level for TCE. Confirmatory sampling indicates that the VI pathway in Building 16 is not complete, and the August 2012 concentrations are anomalous and may have been affected by background sources of material storage. The SS analytical results are presented in Table 1. The IA analytical results are presented in Table 2. The TCE and methane results are summarized on Figure 1.

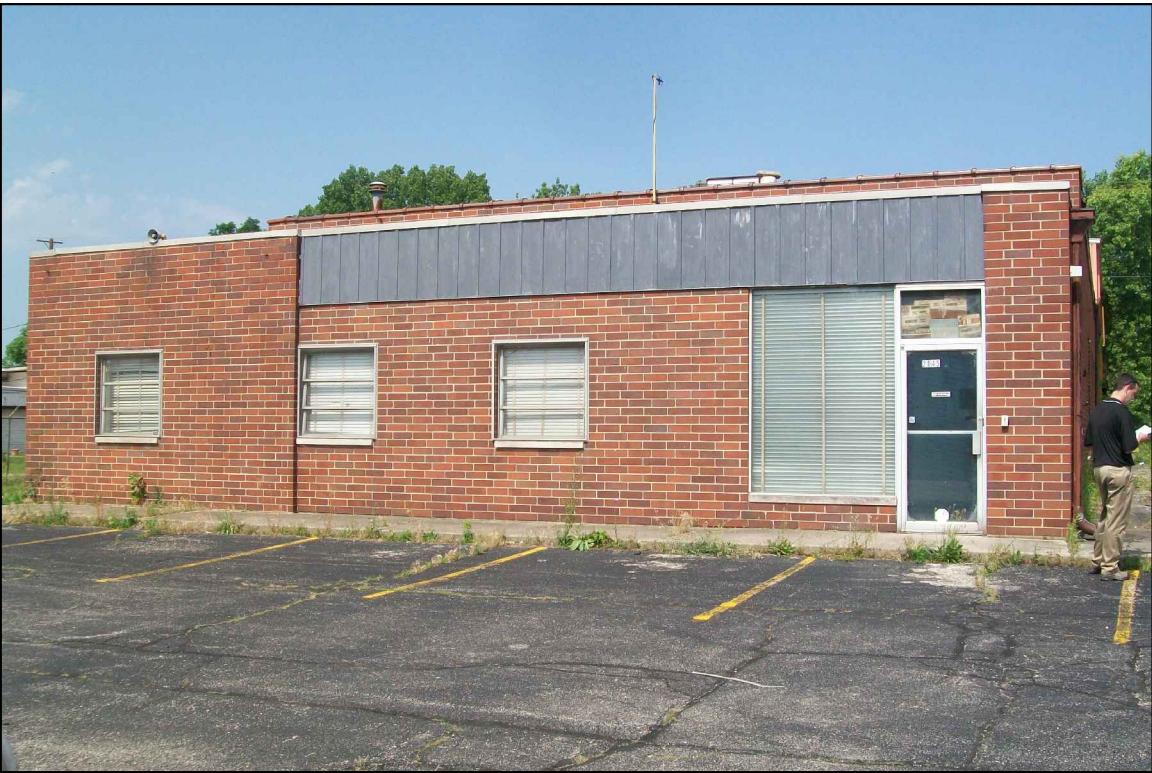
PHOTO 1: EXTERIOR EAST SIDE (STREET-VIEW), LOOKING WEST (JUNE 2011)

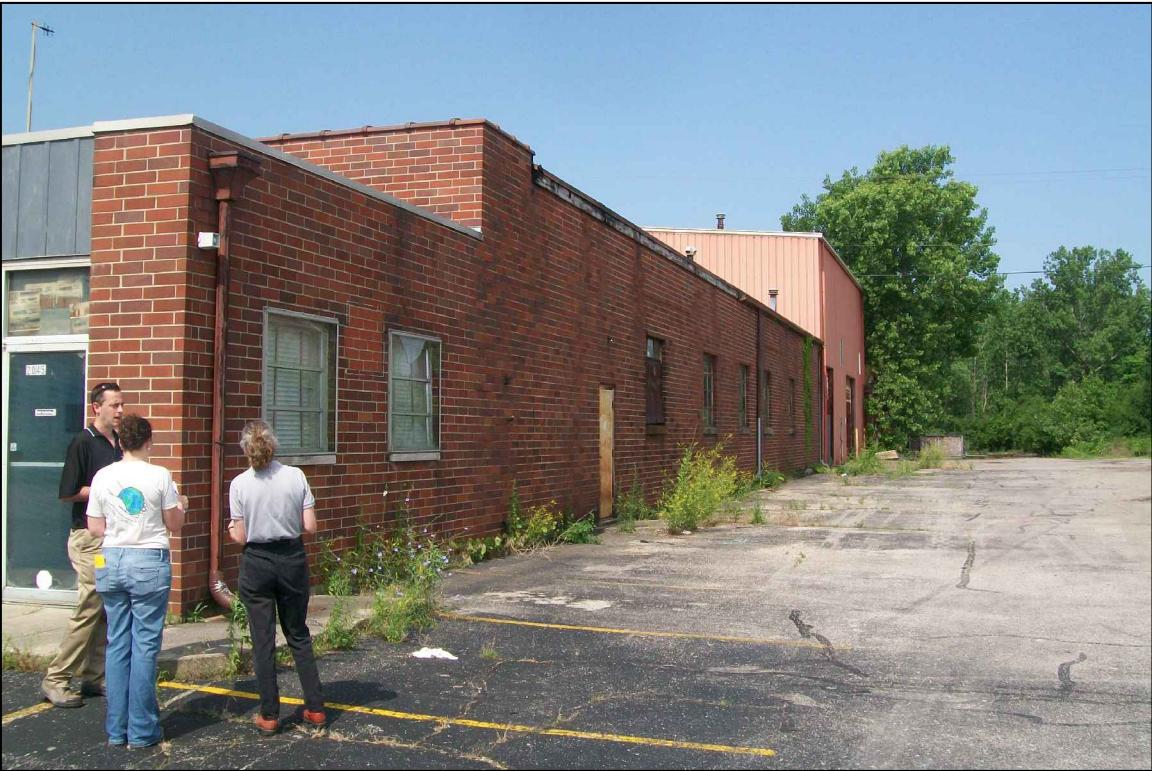
PHOTO 2: EXTERIOR NORTH SIDE, LOOKING SOUTH (JUNE 2011)

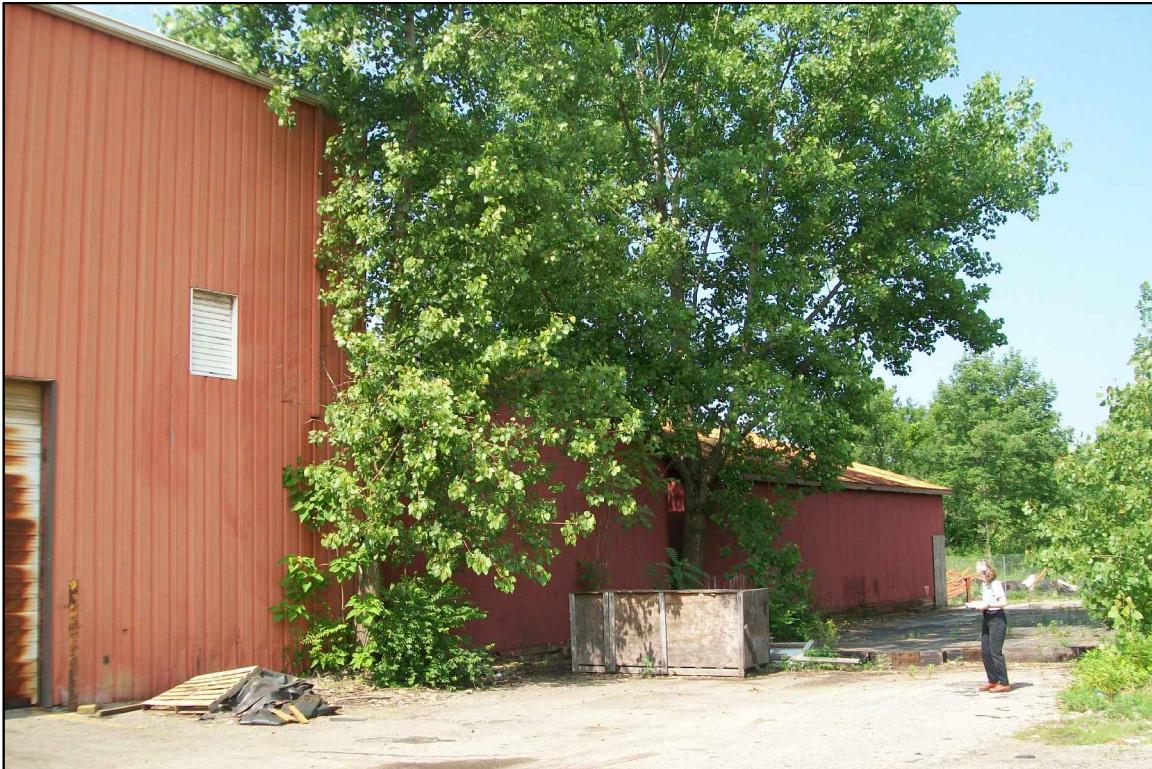
PHOTO 3: NORTH SIDE OF REAR STORAGE BUILDING, LOOKING SOUTH (JUNE 2011)

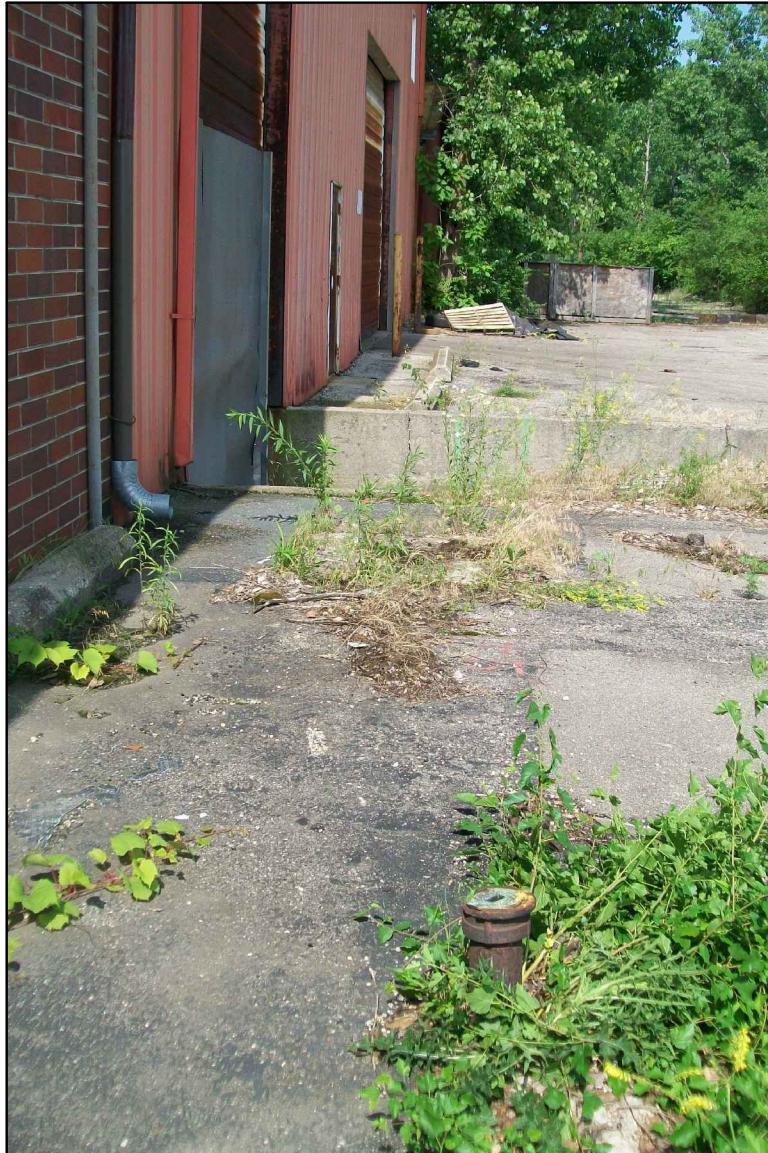
PHOTO 4: LOCATION OF SUSPECTED UST, NORTH SIDE OF BUILDING
(JUNE 2011)

- possible UST I think it was just in B

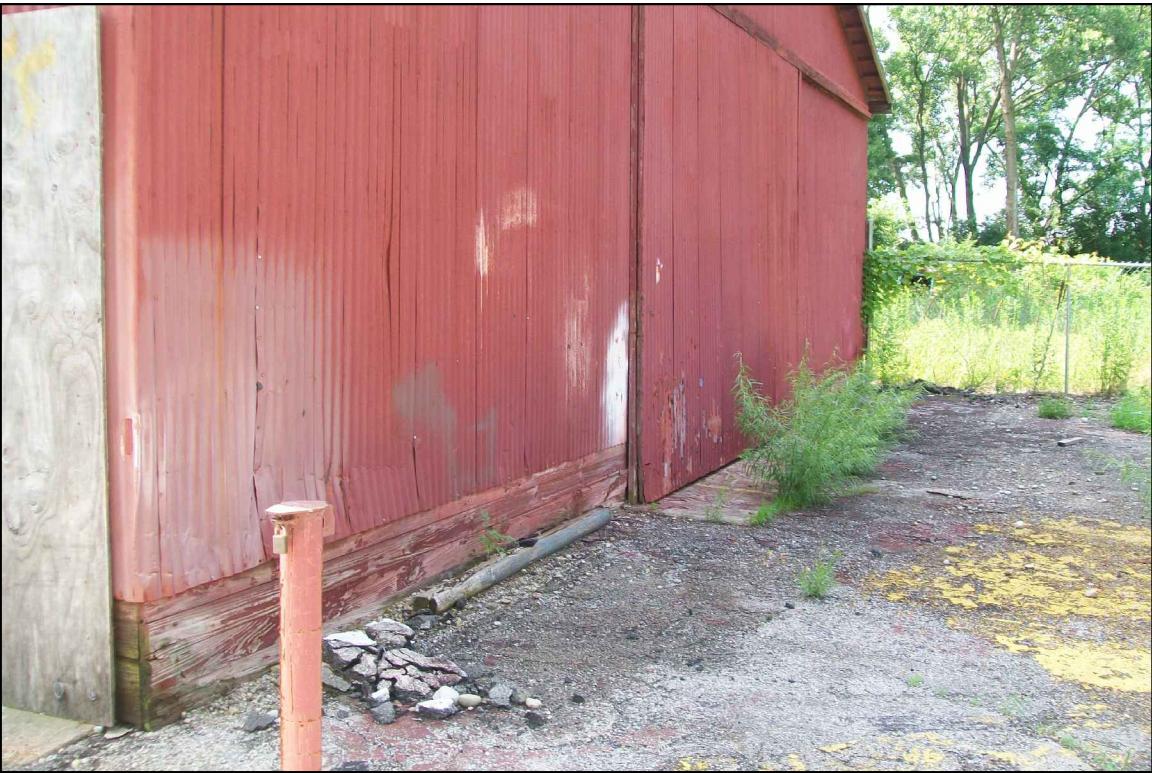
PHOTO 5: EXTERIOR WEST SIDE, LOOKING EAST (JUNE 2011)

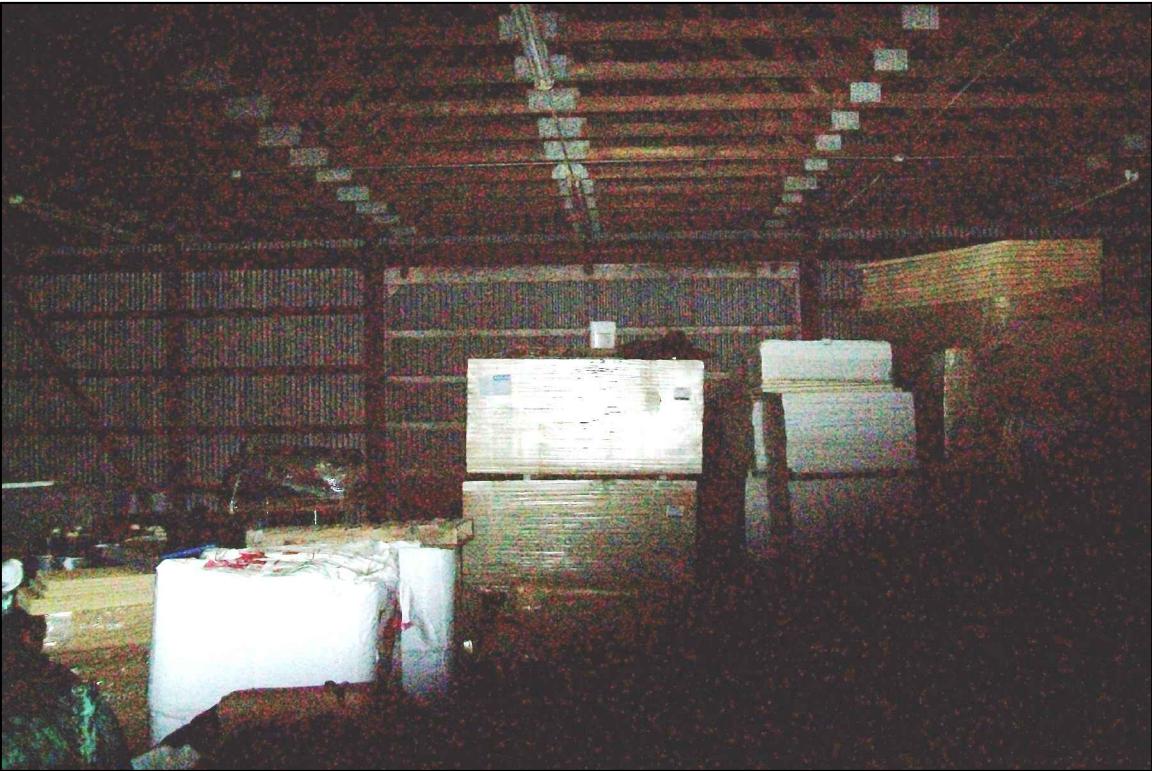
PHOTO 6: BUILDING INTERIOR (JUNE 2011)

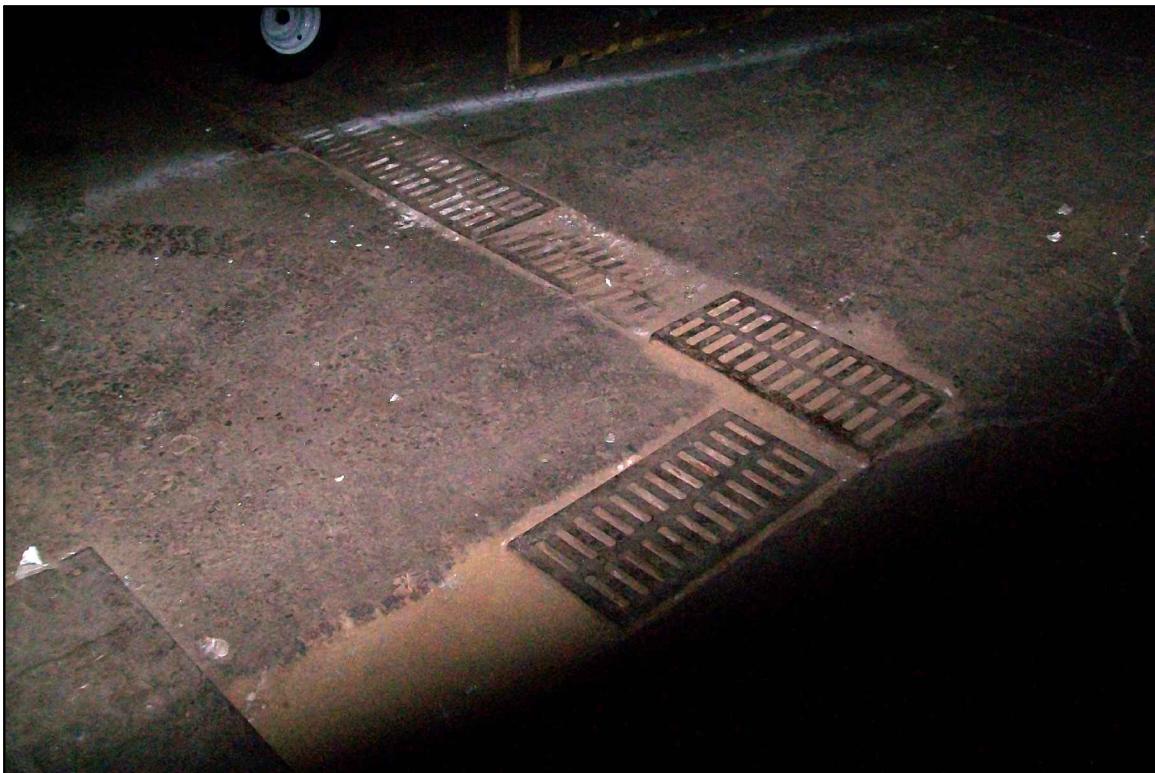
PHOTO 7: FLOOR TRENCH

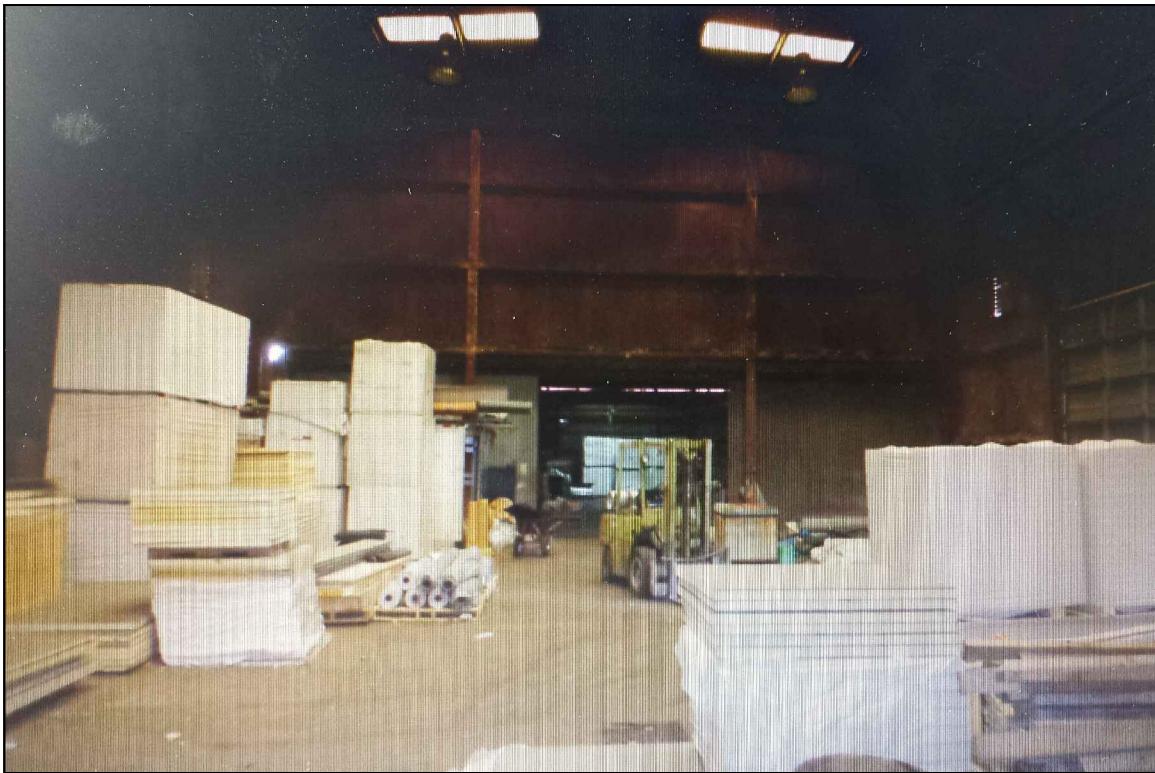
PHOTO 8: BUILDING INTERIOR (DECEMBER 2013)

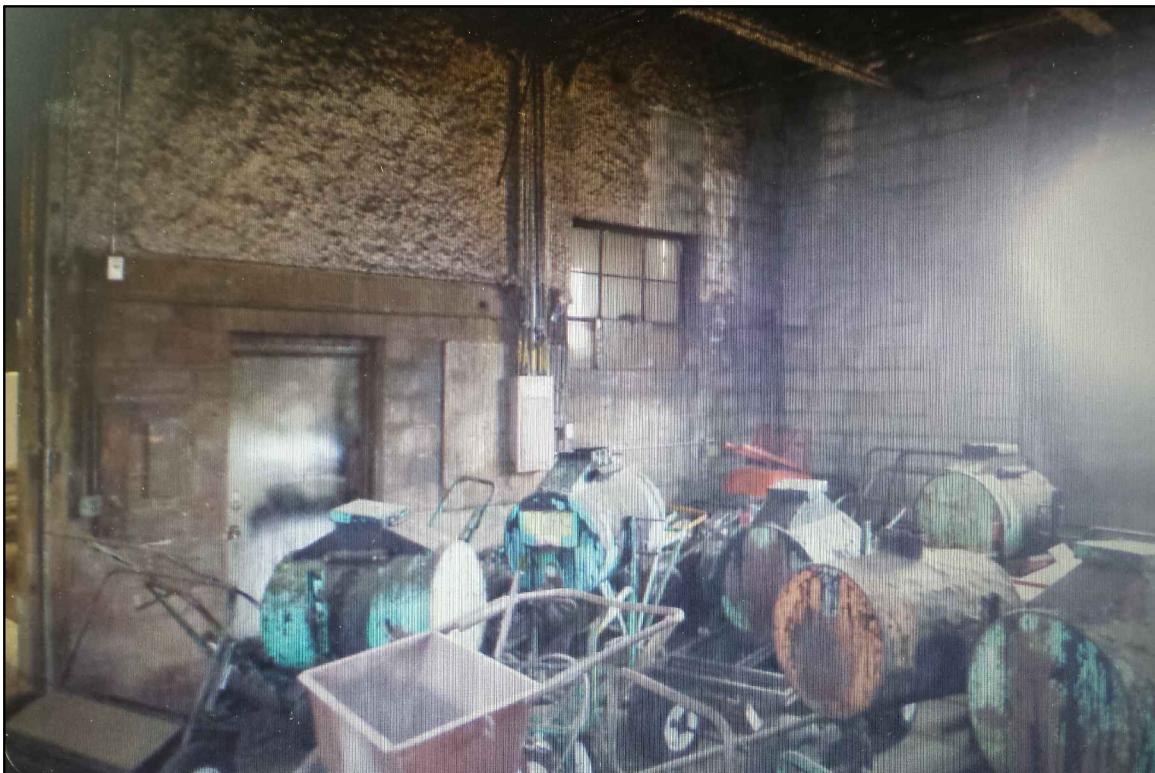
PHOTO 9: BUILDING INTERIOR (DECEMBER 2013)

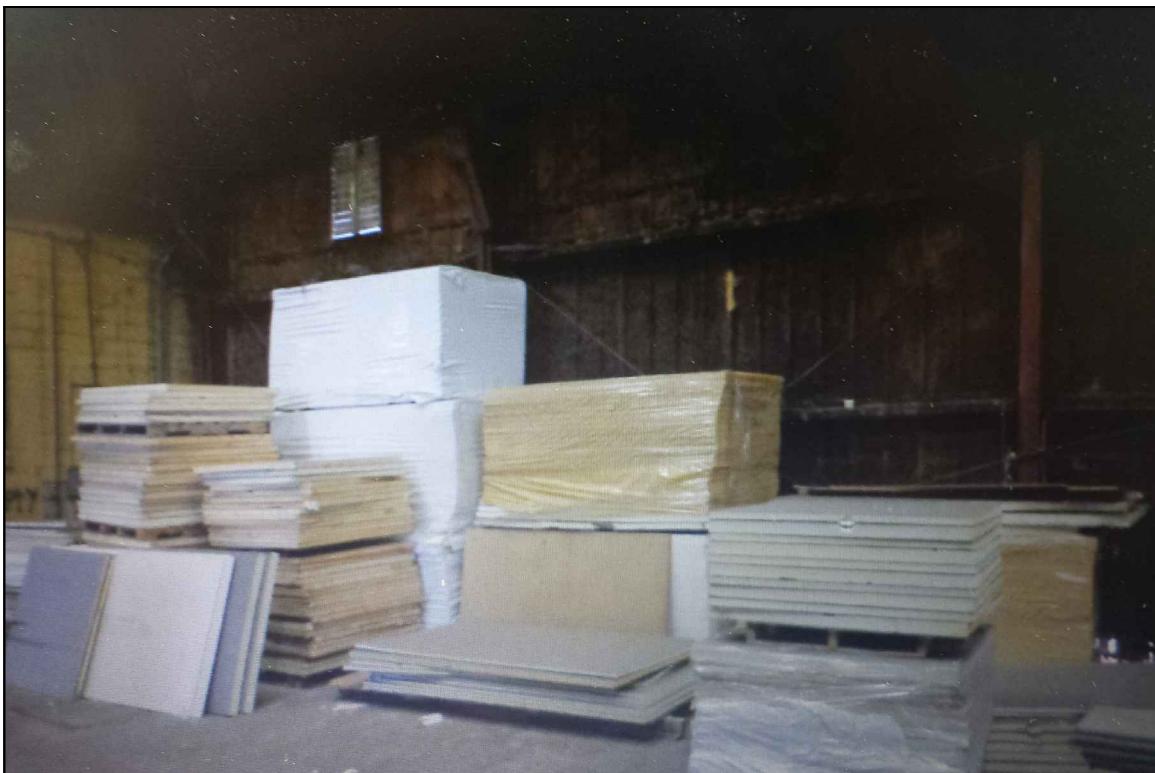
PHOTO 10: BUILDING INTERIOR (DECEMBER 2013)

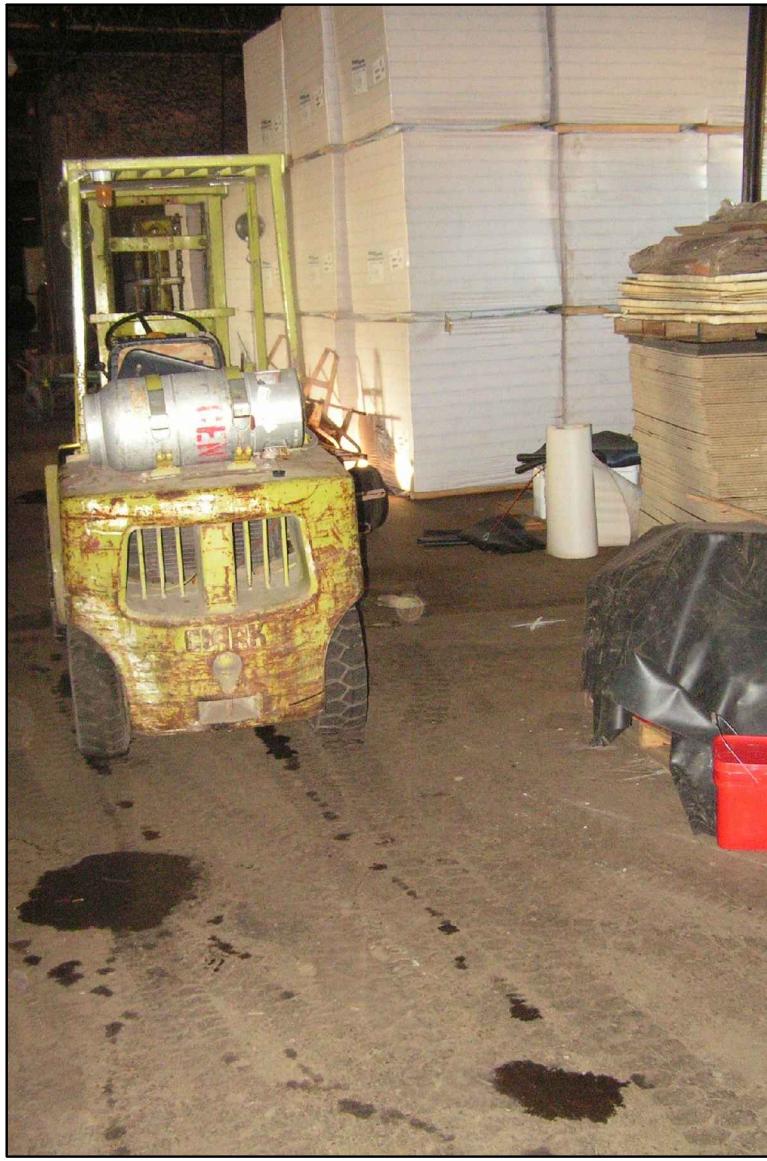
PHOTO 11: BUILDING INTERIOR - SS PROBE D AREA (DECEMBER 2011)

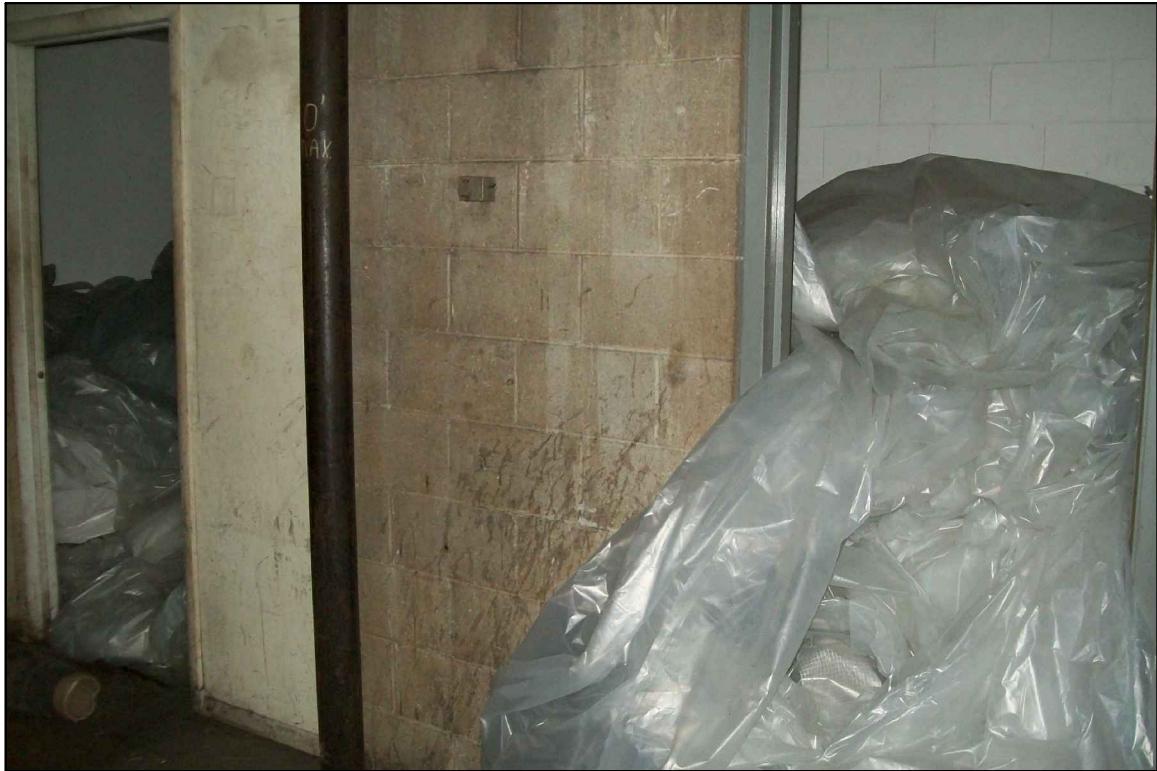
PHOTO 12: MATERIAL STORAGE - POTENTIAL SOURCE OF IA PROBE E EXCEEDANCE (AUGUST 2012)
